Shawnigan Creek Watershed

A F I S H E R I E S P E R S P E C T I V E

Abstract

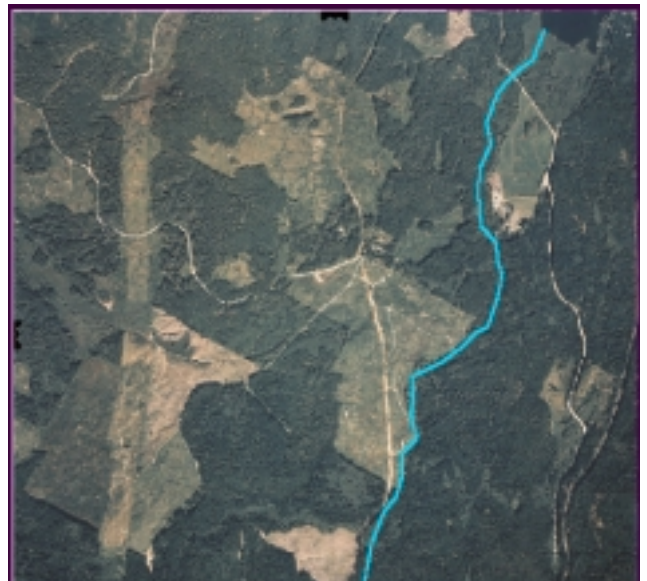
Figure 6: Upper Shawnigan Creek

The lower region of Upper Shawnigan Creek (blue line) is undergoing extensive timber harvesting

Large cutblocks of MacMillan + Bloedel (now Weyerhaeuser) private land have been logged here in recent years. There are also large parcels of crown-owned forest land within the upper watershed, as well as blocks of Timberwest private lands. (See Figure 5)

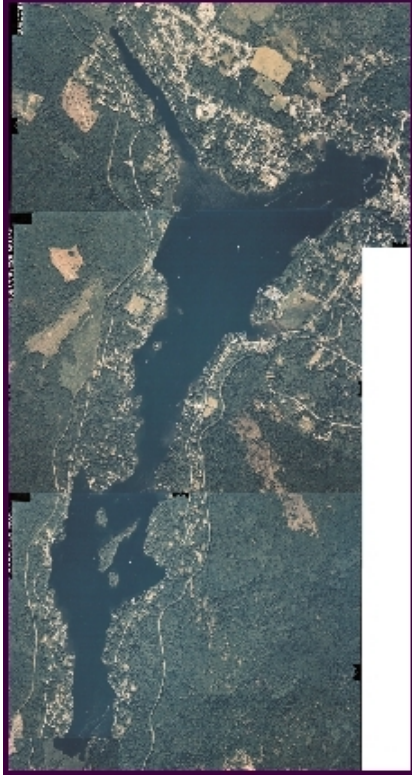
Figure 7: Shawnigan Lake Figure 8: Cameron/Taggart Swamp

Shawnigan Lake (WSA WaterBody ID: 00091VICT - See Figure 7) is the largest natural lake on the southern end of Vancouver Island, south of Cowichan Lake. With an area of $5,270,391\text{m}^2$ ($= 527\text{ ha}$), this lake comprises an unusually large 8% of the total watershed area. The registered elevation of Shawnigan Lake is 116m, although the lake level actually fluctuates over a range of nearly 3m, depending upon the season and the weather. It has a perimeter of 27,981m ($= < 28\text{ km}$). Total volume is calculated at 64 million m^3 . The main lake basin runs in the same generally northerly course as the inflow valley, with one long arm leading to the west. In addition to the inflow from upper Shawnigan Creek, the lake is also fed by a number of smaller, seasonal creeks, the largest of which is McGee Creek on the western side.

The focus area for this report:
Shawnigan Lake (left)
Lower Shawnigan Creek (below)
Cameron/Taggart Swamp (above)

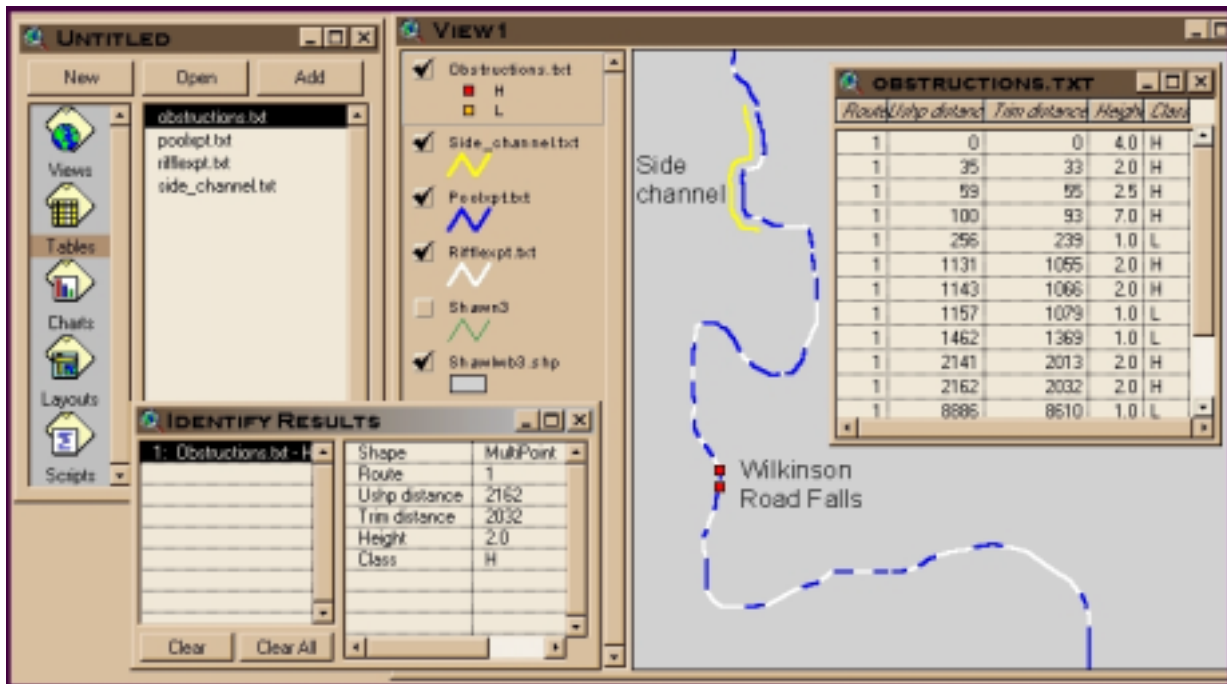
Figure 10: Dynamic Segmentation

An illustration of the use of “dynamic segmentation” to display individual features along a linear theme. Three types of route event theme are shown here: point (Obstructions), linear (Pools, Riffles), and linear-offset (Side-channel). Each theme in the view is shown in a list running down the middle of this ArcView screen capture, with its title appearing above its symbol. Over a greyed background (Shawn3.shp - the BCWSA polygon theme for the Shawngigan watershed) the route theme Shawn3 (built from the TRIM water layer) is added to the view. Although it is not turned on (no check mark beside it, so it is not visible) it serves as framework for the other “route event themes”.

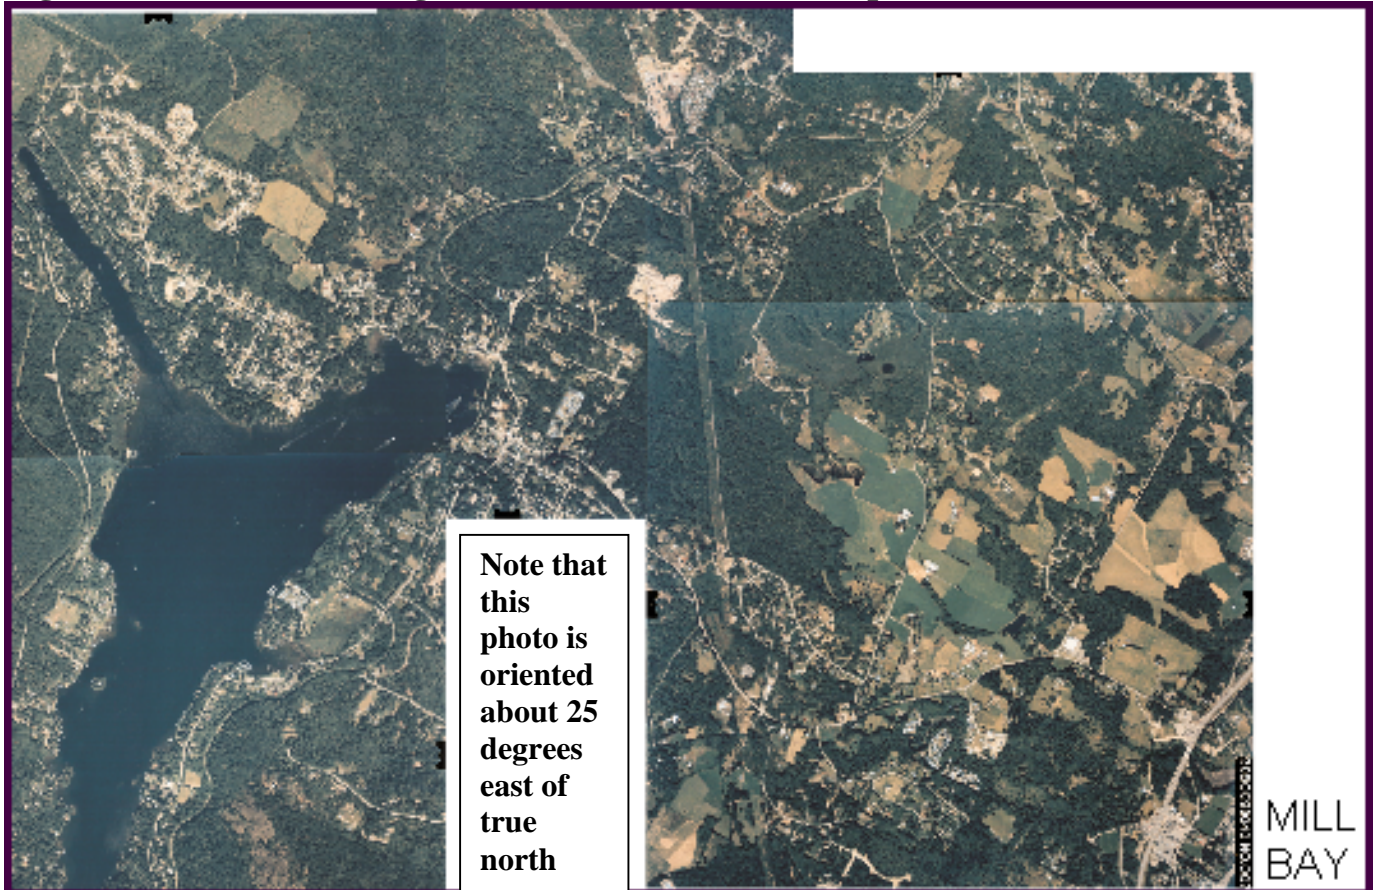
Figure 12: Lower Shawnigan Creek watershed “orthophoto”

Shawnigan Creek watershed boundary shown in red
Roads shown in brown.

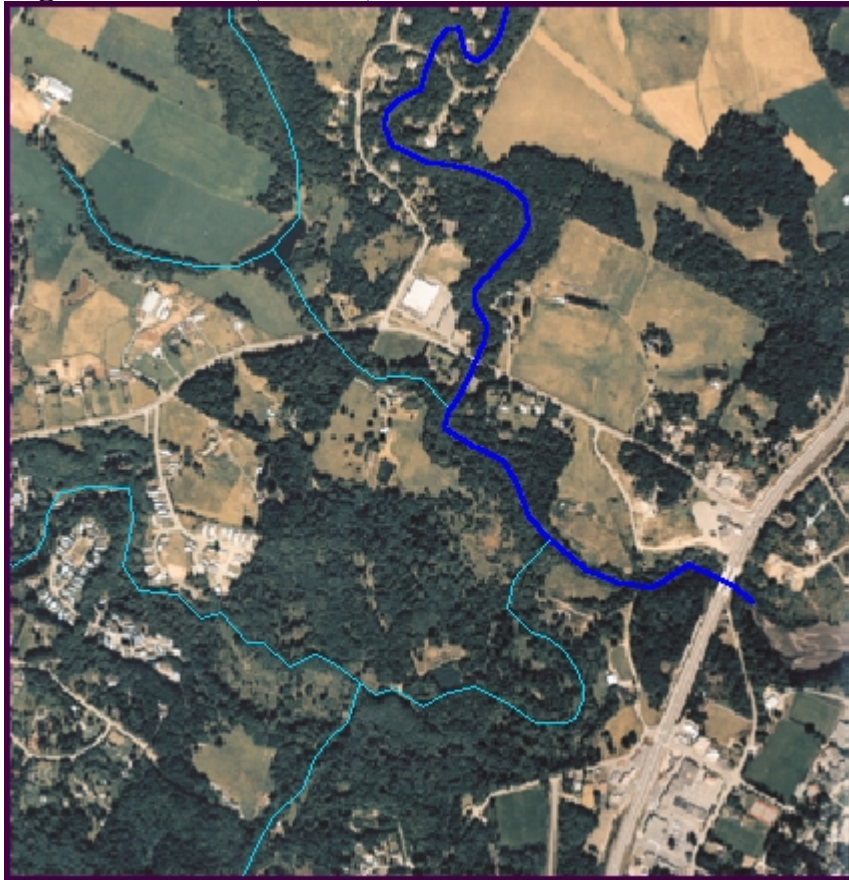
Figure 15: MRI, MRII, and MRII

Shawnigan Creek (dark blue) enters the ocean at Mill Bay (lower right – the tidal mudflats are visible in this photo).

The creek passes under the Island Highway bridge immediately above Mill Bay.

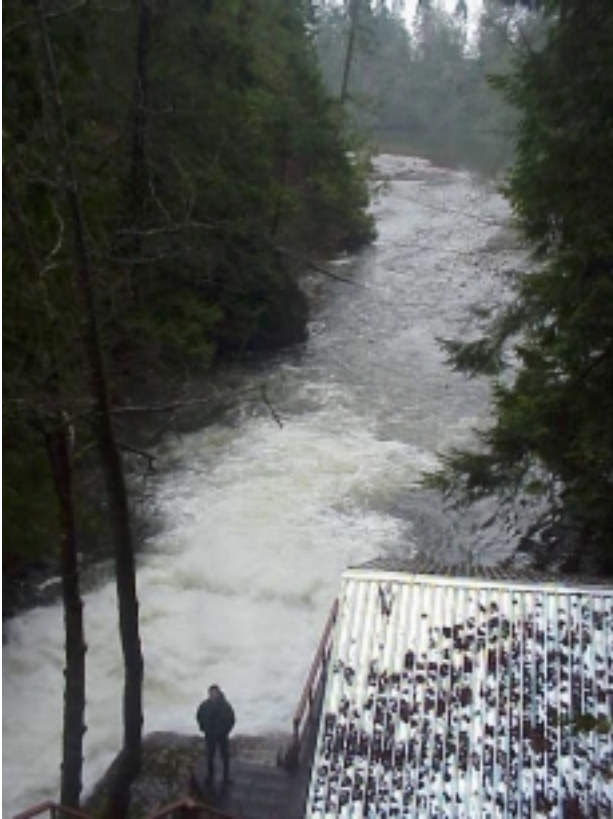
Figure 17: Estuary

Above Right: Low flow, low tide. Note the plunge pool below the falls, and extensive gravel flats in the estuary at low tide.

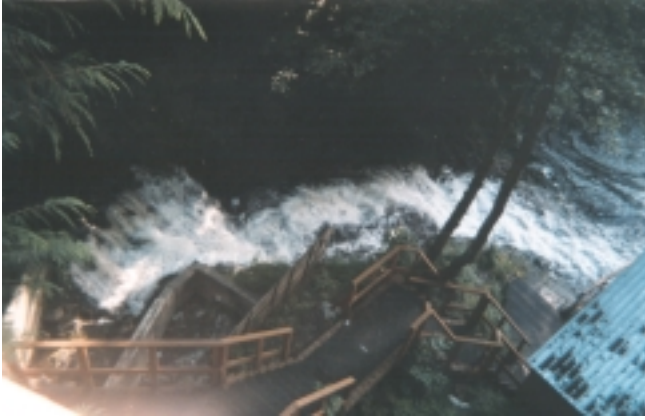
Figure 21: Stairway and coho shed

A shed has been built over a hollow in the bedrock at the tideline beside the waterfall (see Figures 18 and 21). A large diameter heavy-duty plastic pipe with a flow control valve has been cemented into place in Pool #1 above, from which water is diverted into the hollow below the shed, creating a pool. Returning adult coho, stymied at the base of the falls, will (presumably) follow the fresh water inflow into the pool below the shed. A trap door in the floor allows volunteers to scoop up these fish with dipnets (see Figure 22). They are then put into tubs, which are hauled up the steep bluff on metal rails. The cohos are finally transferred into water-filled tubs in the back of waiting pickup trucks, transported upstream, and released at different spots along the lower mainstem of Shawnigan Creek. At the start of Reach 2 the Vancouver Island Highway bridge passes high over a large, deep scour pool of smooth bedrock. This is Pool #3 in the data. It is 25m long, and perhaps 5m deep. A cement pumphouse sits on the west bank (visible on the left in Figures 20 and 23), apparently the site from which Mill Bay Waterworks withdraws water from the creek, under permit from their water license on

First falls, and plunge pool into Mill Bay. Beside is the stairway to the coho capture shed

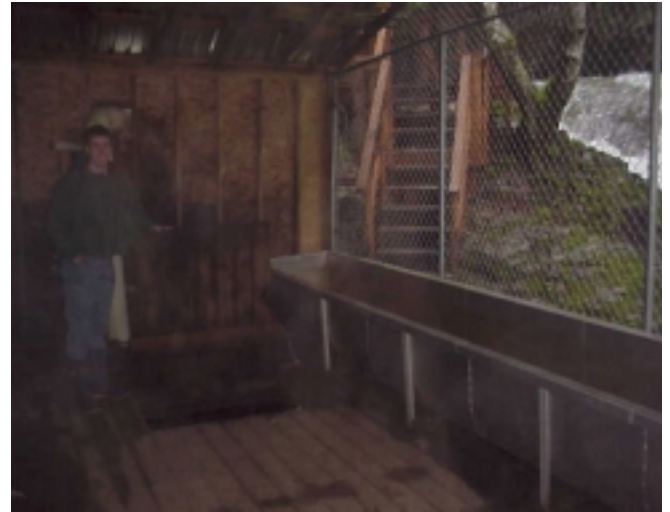
Figure 22: Coho capture shed

Don Merry, standing beside the trap door in the floor of the coho shed.

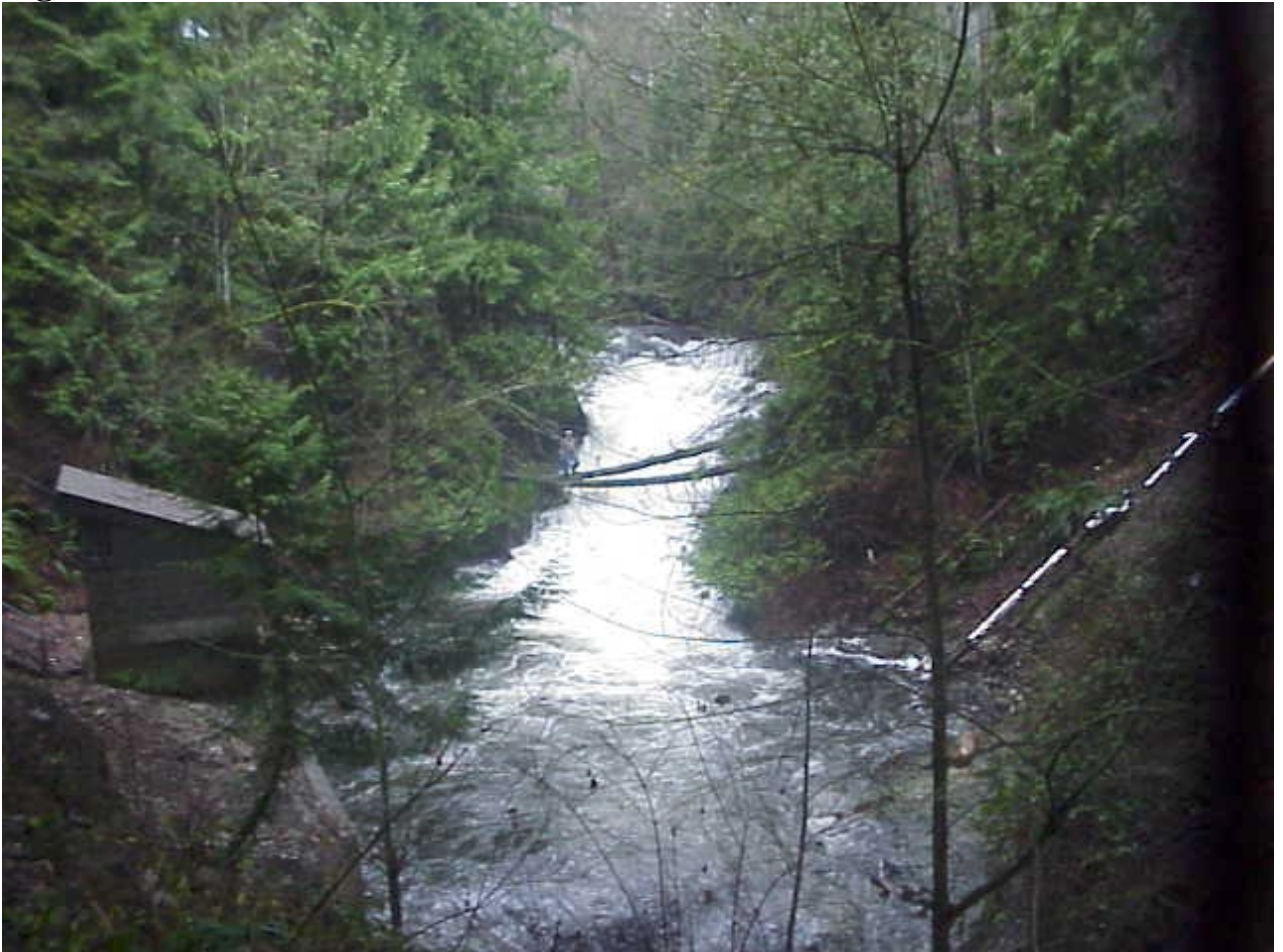
Figure 23: Third falls

Shawnigan Creek falls. This photo shows Pool # 3 in our survey, directly under the Vancouver Island Highway bridge. Mill Bay Waterworks pumphouse (?) is on the left, and pipeline on the right. Above Pool #3 is Riffle #4, an impassible falls which is a barrier to all fish passage.

Shawnigan Creek. This pumping facility does not seem to be very active now, as one would expect if most of the water stored under Mill Bay's storage license is now being withdrawn from Shawnigan Lake instead (see Section 5H).

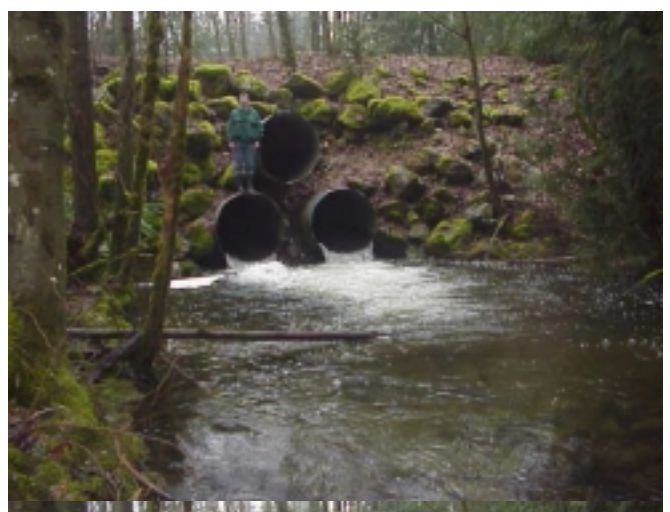
Figure 25: Hollins Creek

Hollins Creek, Don standing on hung culvert. This creek looks like excellent coho habitat.

These Hollins/Handysen tribs run cooler than the mainstem during summer, and appear to be superb coho habitat. Numerous fry were observed in Hollins Creek in the summers of both 1999 and 2000 (more in 1999). There were many that appeared to be larger than the fry visible in the lower mainstem or Upper Shawnigan Creek, suggesting that they might have been coho fry. However, the only salmonid caught in a G-trap in Hollins Creek in 1999 was a cutthroat, and the G-trap set in summer 2000 was immediately stolen. Pole seine sets in Hollins Creek during summer 2001 returned only cutthroat fry. There is a hung culvert about halfway up Hollins Creek (see Figure 25). It is interesting to note that fry were observed both above and below this culvert in good numbers during summer 1999. We also spoke with a local resident who said he had observed coho spawning above this culvert in the past. They may be able to pass this culvert at some flow levels.

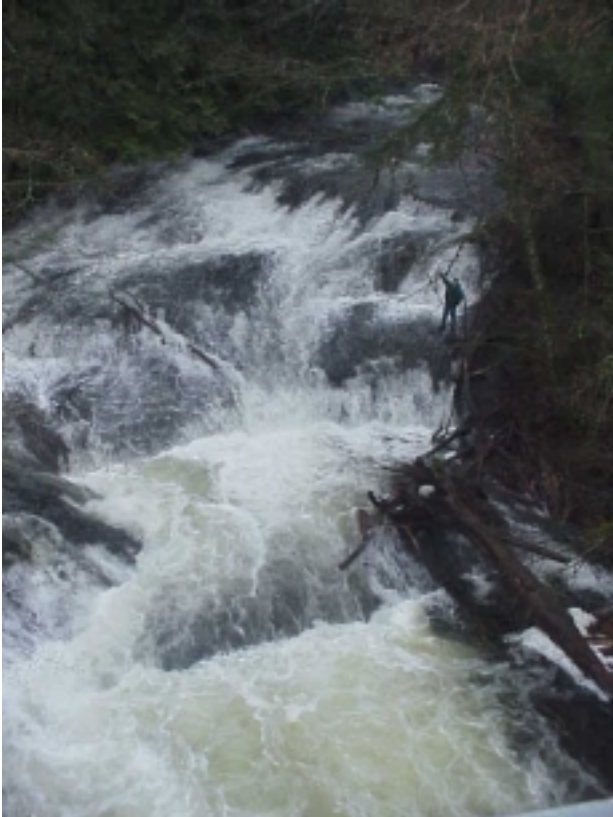
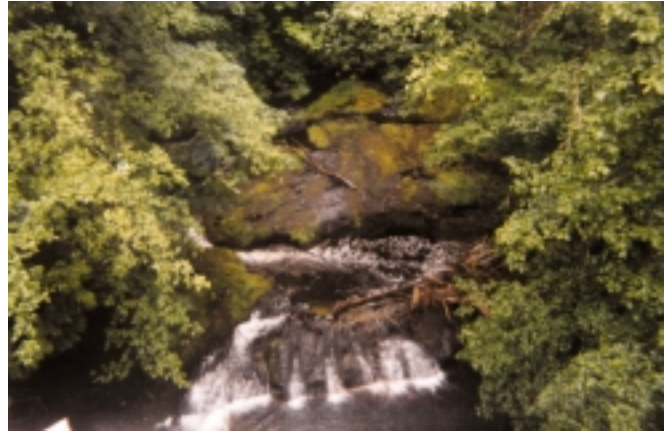
Figure 26: Shgn/Mill Bay Road Falls

Shawnigan/Mill Bay Road falls.

High flow, left. Don Merry standing on right.

MRIII begins at the Shawnigan / Mill Bay Road falls (Riffles # 22 and 23 - see Figures 26 and 27), and extends 1010m upstream to another set of falls located just downstream of the footbridge which has replaced the former Wilkinson Road auto bridge (Riffles # 46 and 47 – see Figures 28 and 29). A map showing the locations of all the falls which form complete barriers to fish passage is presented in Figure 30. This macro-reach is identical with the single reach we called Reach 7 in our survey. Both of these major falls are two-stepped jumps of about 2m in height (4m total), with a shallow pool located between the jumps. Both sets of falls represent total or near-total barriers to upstream migration of fish. Thus, the intervening MRIII is a self-contained unit, with no possibility of migration of fish from the reaches below, and no possibility that the fish it contains can migrate upstream to the stream reaches or the lake above. In addition to the major falls at each end, it is characterized by numerous smooth bedrock pools, as well as a number of smaller jumps and slides. Two of these are at least 1m high, and were recorded in our GIS data. On the western side of the creek, the flat bluff above the forested creek ravine is dominated by the Kerry Park Recreation Center and its associated playing fields and paved parking lots. Further upstream the land use becomes residential – infrequent houses on large, heavily forested acreages. The creek is cutting down into a small gorge here. The houses of upland owners are seldom visible from the stream below, and appear to have little direct impact on the stream habitat.

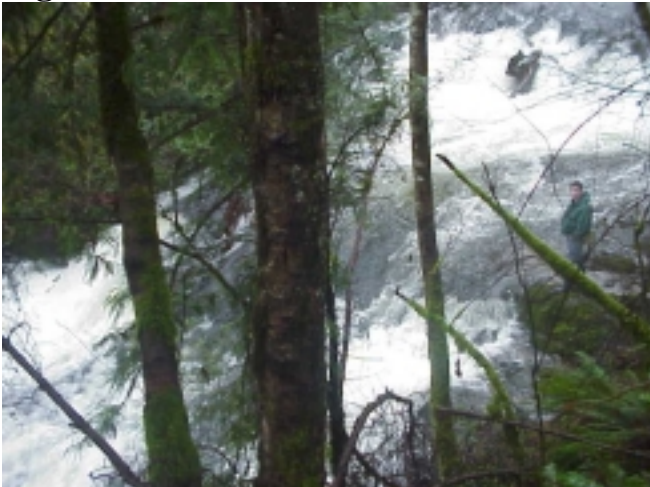
Figure 28: Wilkinson falls

These falls are the second major barrier to fish passage in the Shawnigan Creek mainstem, after the series of falls near the mouth in Mill Bay.

Don beside Wilkinson Road falls, high flow

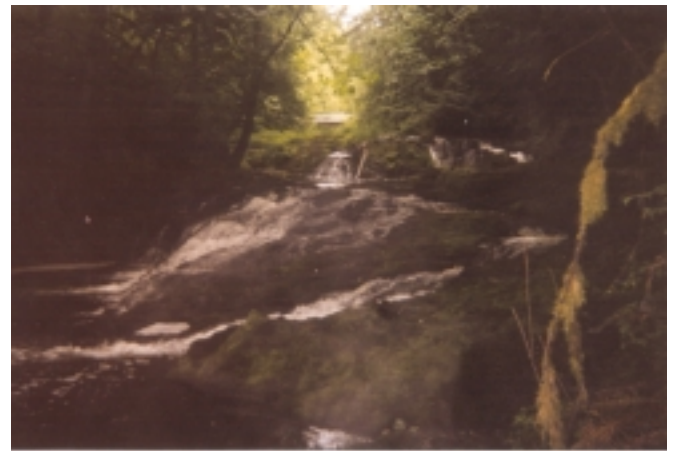
Figure 29: Wilkinson falls

Wilkinson Road falls, low flow.

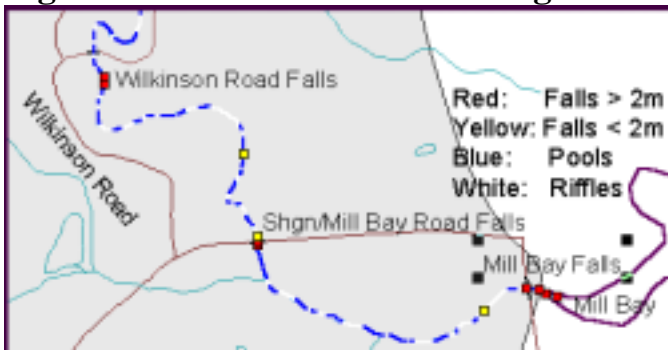
Figure 30: Falls on lower Shawnigan Creek

Three main sets of falls block fish migration in Lower Shawnigan Creek. All are located within the first 2200m above the ocean. These are the falls (shown in red) assessed by Ian Ross of DFO: the multiple falls near Mill Bay, a pair of falls near Shawnigan Mill Bay Road, and another pair near Wilkinson Road.

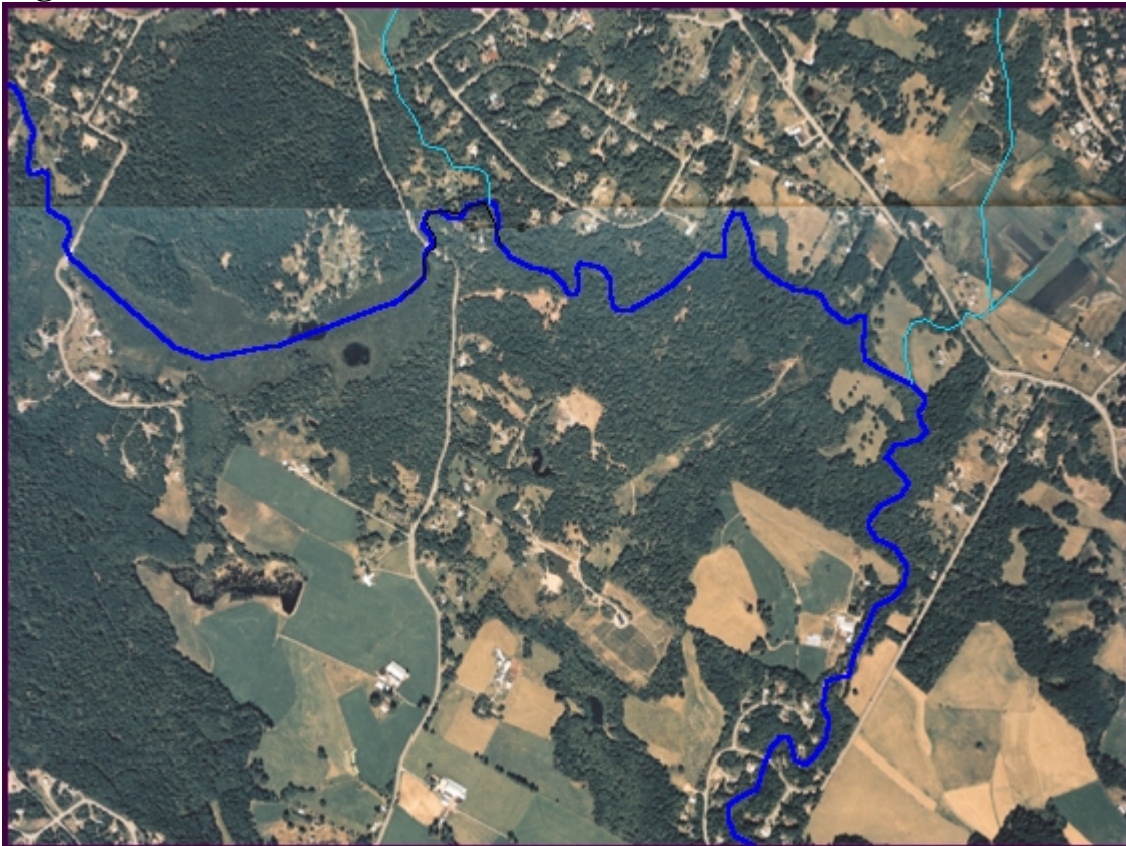
Figure 32: MRIV and MRV

On the aerial photo Reaches 10-15 are seen to pass through an almost unbroken cover of dense forest (see Figure 32). It is rare to find a stream of this size, surrounded by a population so large, and so near to major metropolitan areas, that is as undeveloped as the MRIV section of Shawnigan Creek. This heavy timber, combined with a gentler gradient and a more erodable substrate, might be expected to produce larger, deeper pools. The ArcView printout of MRIV shows a number of long pools (see Figure 31). This part of the creek is intriguing, and worthy of further study. I wish I had been able to accompany Lucas on his survey, and I would like to go back and see it for myself, perhaps in a canoe some day.

The same area as in Figure 30 above - note that the photo is not oriented to true north.

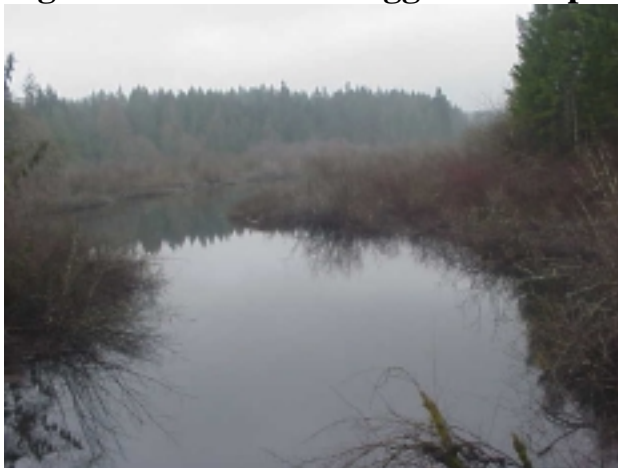
Figure 33: Cameron/Taggart swamp

Cameron/Taggart swamp outlet at Cameron/Taggart Road. This lead of open water soon ends in disappears into a dense willow swamp.

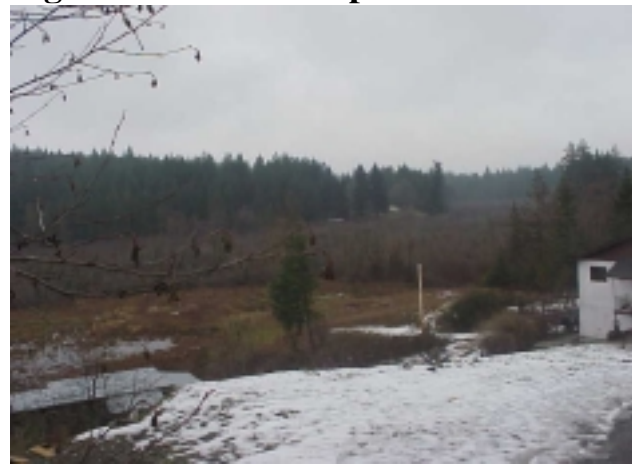
Figure 34: C/T swamp

MRV is the Cameron/Taggart swamp (see Figures 8, and 31-34), coded as wetland 00081VICT in the BC WSA. The extent of this wetland is listed as 251,079 m² (= 25.1 ha), at least 95% of which is a uniform, trackless jungle of willow swamp. With an area of 25ha it is the largest waterbody in the entire watershed, aside from Shawnigan Lake itself. MRV is identical to Reach 16 in our USHP data, and also identical to the single pool # 127. This pool begins at the top of the riffle located just below the Cameron/Taggart Road Bridge, and extends more than 1,000m upstream through impenetrable willow swamp to the Shinrock Road Bridge. The level of this wetland is maintained by a gravel riffle located a few meters below the Cameron/Taggart bridge. An intermittent beaver dam at the head of this riffle backs the water up slightly higher when it is “operational”.

Looking north from Shinrock road across the Cameron/Taggart swamp, over hectares of trackless willow.

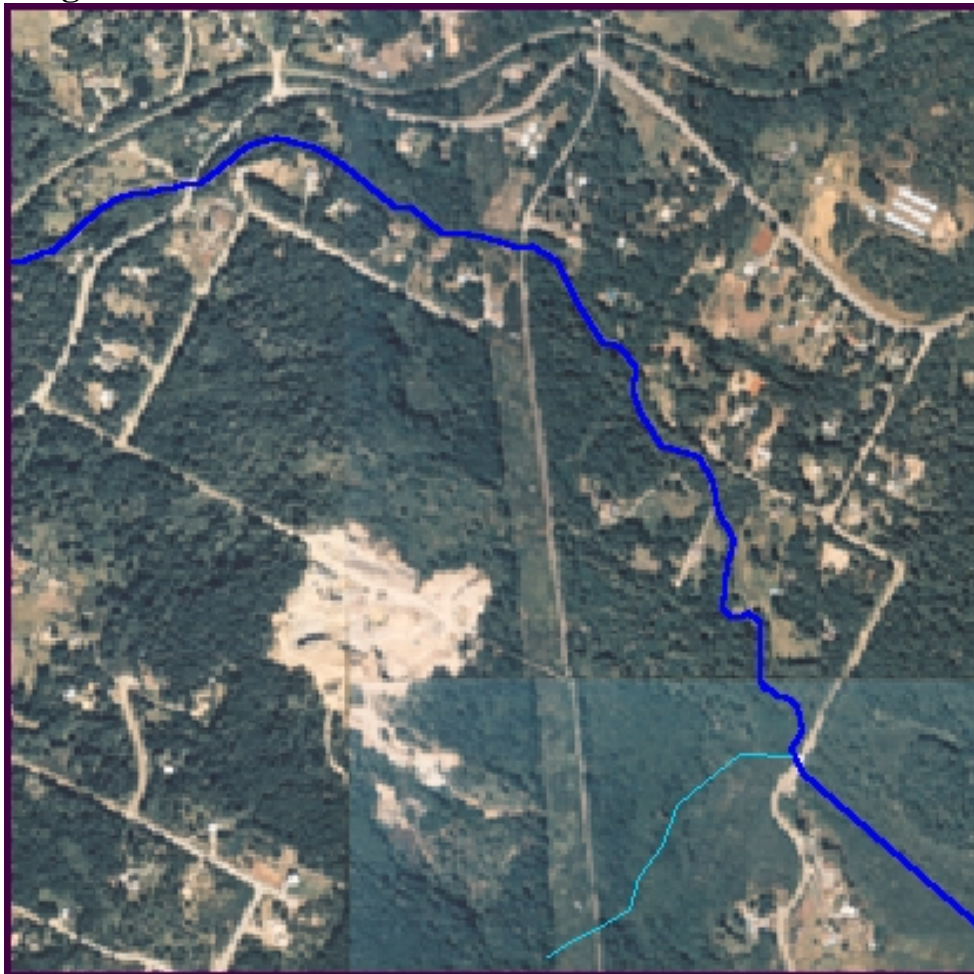
Figure 36: MRVI

MRVI: Land use is residential, large acreages. Much of the land area is cleared, but the riparian zone is still largely forested. The origin of the large clearing to the left of the powerline is unknown.

The orientation of the photo is not true north. Compare the swath of the powerline running through the middle of the photo with the powerline shown on the ArcView map in Figure 34, which is oriented north/south.

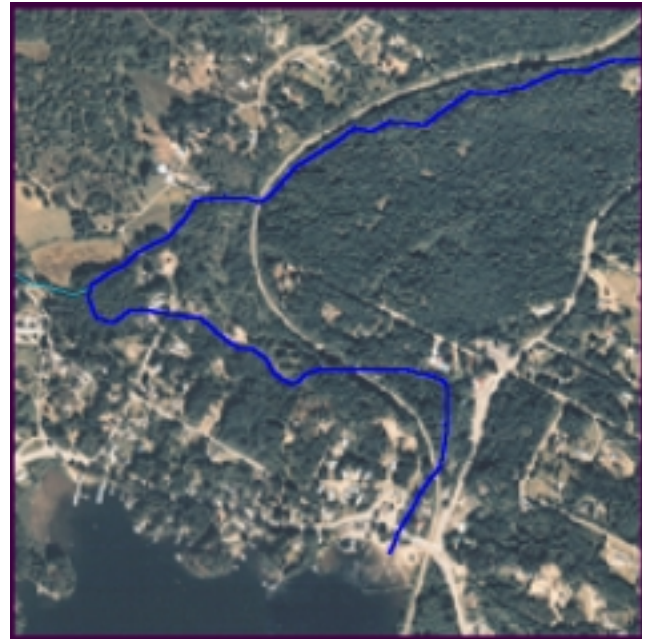
Figure 38: MRVII and MRVIII

MRVII, and MRVIII: The red square indicates the location of the Shawnigan Lake dam. Orientation of map is true north (photo is shifted to the east). The most prominent features in the photo are the broad curve of the E+N Railway (center) and S-bend shape of Shawnigan/Cobble Hill Road (right).

MRVII begins at the start of Reach 22 (see Figures 13, 14, 37 and 38). The nature of the habitat within this stretch differs fundamentally from that in MRVI below in a number of ways:

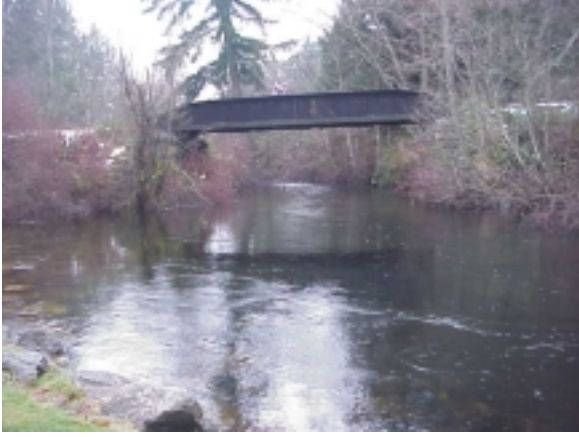
Figure 39: First rail bridge

First E+N rail bridge below Shawnigan Lake, located at chainage 11,191m in MRVIII. There is flow through MRVIII when the lake is high. Flow stops here when the lake drops, and all of MRVIII becomes stagnant.

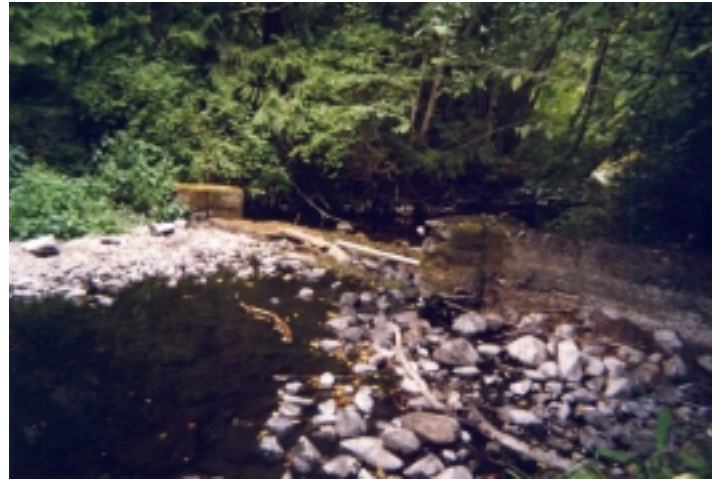
Figure 40: Old dam, August 2000

The remains of an old dam, located at chainage 10655m in MRVII. Notice the extremely low flow level, typical of summer conditions here in 2000.

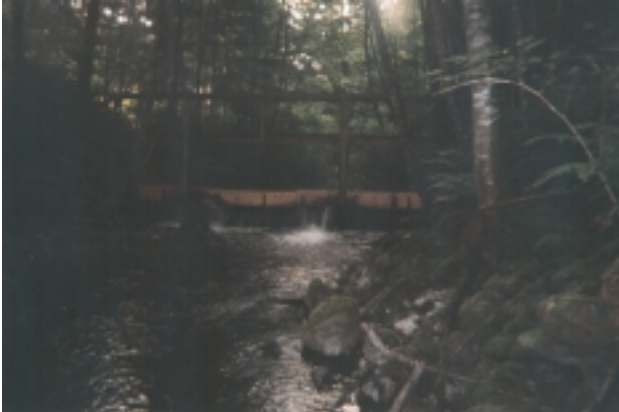
Figure 41: Shawnigan Lake dam

The current Shawnigan Lake dam, or “weir”, located at chainage 10,979m, looking upstream. Low flow on left, moderate flow on right.

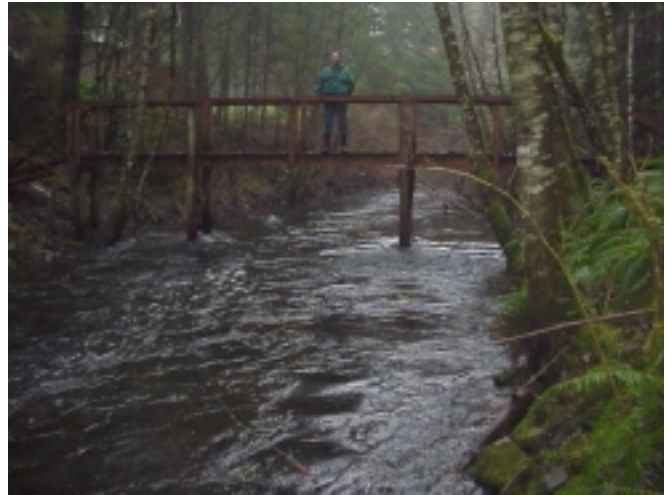
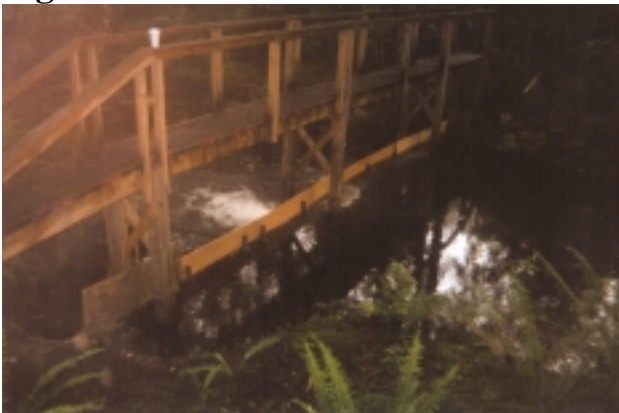
Figure 42: The dam

Shawnigan Lake dam, looking downstream, low flow, summer 2000. The flashboards can be seen propped against the posts of the walkway.

After lake levels drop in spring, and the flashboards are installed in the dam (see Section 5.4), MRVIII becomes an essentially stagnant pool, with depths approaching 2m in places. The bottom is almost entirely mud. I have visited MRVIII on numerous occasions, and canoed down its length twice. In spite of what appears to be excellent habitat - at least for sunfish and baby bass, if nothing else - I have seldom observed fish of any kind present in this long pool other than a few salmonid fry rising in summer 2001. The exception to this is the area closest to the lake outflow, above the Renfrew Road bridge. This shallow flat is more sandy than muddy, and serves as a spawning zone for pumpkinseed sunfish in the spring. Kokanee – one of the few truly “natural” fish left in this lake - were also observed spawning in the lake outflow in 1999 (T. Michalski, pers. comm.).

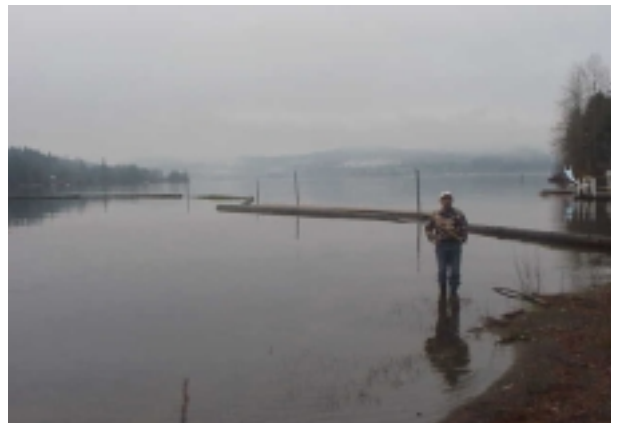
Figure 44: Shawnigan Lake

Shawnigan Lake outlet, 11471m. We ended our USHP survey here.

MRVIII begins at 10979m, at the Shawnigan Lake dam, or “weir”, and extends approximately 500m to actual lake outlet itself at 11471m (see Figure 44). It is identical with Reach 27 in the USHP data, and also identical with the single Pool #203. The construction and operation of the dam is a subject that is too complicated to get involved with in this section of the report. For a more detailed discussion of issues regarding the dam see Section 5.3.

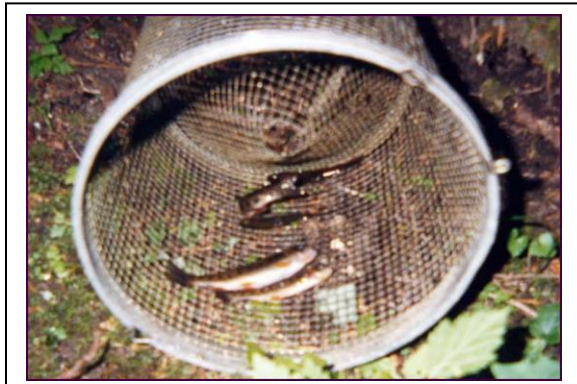
Figure XX: Cutthroat fry in G-trap

Fry trapping was conducted with "G-traps" (screen mesh cages with cone-shaped entrances, similar to the familiar prawn traps), baited with cat food and/or canned tuna. The G-traps unclip and come apart into halves, so that all fish can be released unharmed. My brief foray into the world of G-trapping was cut short when I found out how attractive the traps are to thieves. After losing 2 traps in 2 days I decided to wait until next year, and perhaps switch to beach seines.

Fry trapping sites in 1999/2000: The numbers correspond to the **Site #** column in **Figure XX** above. The inset shows the site on upper Shawnigan Creek. Cutthroat fry were caught or observed at all locations except 3 and 4.
